TECHNICAL REPORT

Report of: Segmental retaining wall block testing

Project: Murata Retaining Wall

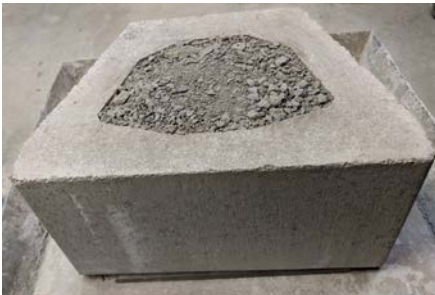
Photo 1: Hollow portion of block filled with aggregate by shoveling. No vibration was used.

Bulk Density (Unit Weight) – Procedure Used Shoveling					
Test No.	Volume of Void in Block (ft ³)	Weight of Block (lbs)	Weight of Aggregate (lbs)	Total Weight of Aggregate and Block (lbs)	Bulk Density (Unit Weight) pcf
1	0.2506	58.85	24.13	82.98	96.3
2	0.2506	58.85	24.95	83.80	99.6
Average	0.2506	58.85	24.54	83.39	98.0

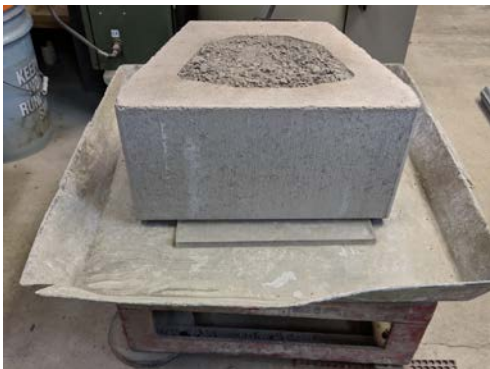
Photo 2: Hollow portion of block filled with aggregate and consolidated by a vibrating table operating for approximately 1 min. until no visual consolidation of aggregate was observed.

Bulk Density (Unit Weight) – Procedure Used Vibratory Table					
Test No.	Volume of Void in Block (ft ³)	Weight of Block (lbs)	Weight of Aggregate (lbs)	Total Weight of Aggregate and Block (lbs)	Bulk Density (Unit Weight) pcf
1	0.2506	58.85	25.09	83.94	100.1
2	0.2506	58.85	25.26	84.11	100.8
Average	0.2506	58.85	25.18	84.03	100.4
